Danville, Illinois

Brownfields Program

Brownfields Assessment Final Report

February 2015

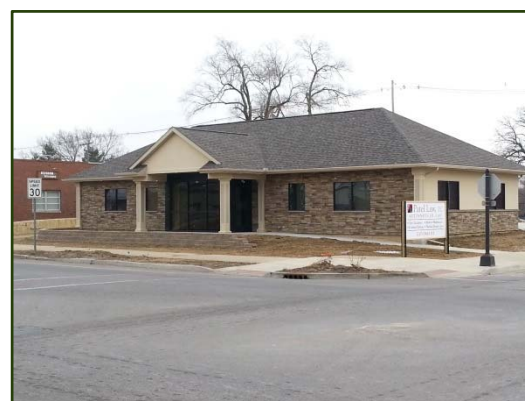
Figure 2.
401 N. Vermilion - Redeveloped as a law office

Following the Phase II ESA, the City worked with environmental professionals to conduct additional site investigation work that included the demolition of the existing building and foundation, removal of a drain pit and disposal of its contents, and ground penetrating radar/electromagnetic survey investigations for potential underground storage tanks (USTs), none of which were found.

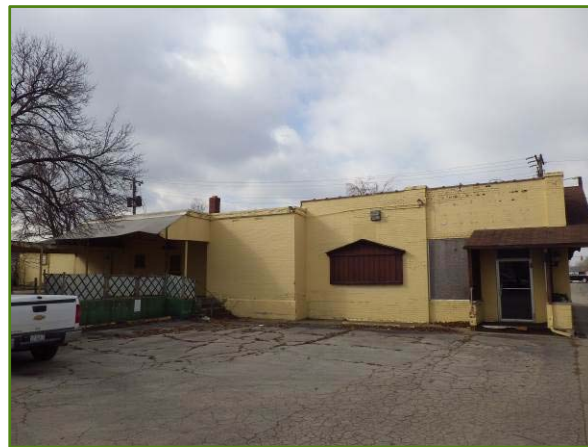
Figure 3.
204 West Fairchild Street - Former Bakery Building

At the time of the Phase I Environmental Site Assessment (ESA), the property was unoccupied. Prior to vacancy, the property was occupied by a bakery and a residence. The property contains two structures, an approximately 4900 square foot, one story commercial building and an approximately 1,500 square foot, two story residential structure.

Working with a Qualified Environmental Consultant (QEC), the City of Danville completed a Phase I ESA on this site on February 27, 2015. The ESA identified the following recognized environmental conditions (RECs) associated with adjacent properties: 1) the historical underground storage tanks (USTs) on the west adjacent site (208-212 West Fairchild); 2) the historical dry cleaners on the north adjacent site at 205 West Fairchild; and 3) the historical battery repair shop on the west adjacent site at 214 West Fairchild.

The ESA identified the following business environmental risks (BERs) that exist beyond CERCLA liability and may be associated with the property, based on the construction dates of the buildings on the property (circa 1905 and 1954): 1) there is a potential for building materials to contain asbestos; and 2) there is a potential for painted surfaces to contain lead above regulatory levels.

Recommendations in the Phase I ESA included confirmation sampling of soils, soil gas and/or groundwater to confirm or refute the presence of hazardous substances and/or petroleum associated with the identified RECs.

In order for redevelopment to move forward, the existing buildings will likely need to be demolished. The property is a likely candidate for commercial/retail redevelopment.

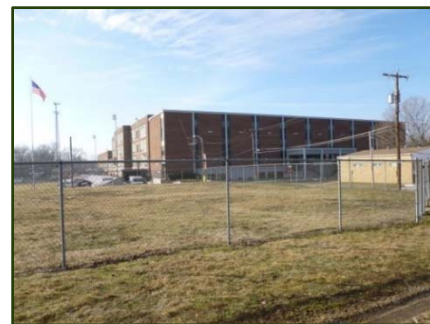
Figure 4. - 307 East Fairchild St., shown adjacent to Danville High School

Several residences occupied this 0.49-acre property from approximately 1893 to 1949, followed by Danville Plating Company from approximately 1947 to 1982. By about 1972, all structures on the property except Danville Plating Company were vacated and demolished. And by 1983, all Danville Plating Company structures were demolished and the property was completely vacated. Danville School District #118, the current owner, acquired the property in 1982. At the time of the Phase I ESA, the property was a padlocked, chain-link-fence-secured vacant lot with grass cover and no structures.

The City of Danville, working with a qualified environmental consultant, completed a Phase I ESA on this property on March 18, 2013, which identified one Recognized Environmental Condition (REC): past use of the property for metal plating¹.

The Phase I ESA also identified four significant data gaps, including 1) the lack of availability of the owner/occupant to discuss occupancy and operations; 2) possible undocumented fill material placement on property; 3) inability to conduct a walkover on the property due to a padlocked chain link fence; and 4) the inability to conclusively determine the exact composition of all plating and waste materials stored on the property.

The City of Danville, working with a qualified environmental consultant, completed a Phase II ESA on this property on September 24, 2013, in order to conduct soil and groundwater investigative sampling at or near the REC identified in the Phase I ESA. The investigative activities included soil borings and permanent groundwater monitoring wells that were used to collect soil and groundwater samples to provide quantitative information regarding the presence or absence of contamination associated with the identified REC. A review of soil sample lab results concluded minimal inorganics exceeding Tier 1 Soil Remediation Objectives. Review of groundwater lab results concluded minimal concentrations of inorganics exceeding Class I Groundwater Remediation Objectives. Class II Groundwater Remedial Objectives were not exceeded.

The Phase I ESA recommended confirmation sampling of soils and/or groundwater to confirm or refute the presence of hazardous substances and/or petroleum products associated with the identified REC and significant data gaps.

The Phase II ESA included a recommendation that the site be enrolled in Illinois EPA's Site Remediation Program (SRP). The Phase II ESA notes that in the event any in-place materials are cored out, the material will need to be profiled and manifested, then hauled by a licensed waste hauler to a permitted landfill.

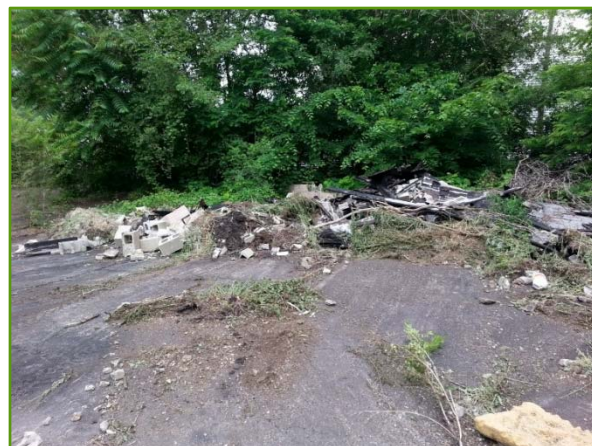
Figure 5.
518 North Franklin Street - Former Triangle Lumber

From approximately 1907 to 1952, this 0.53-acre property was used as a planing mill and lumber yard. At the time of the Phase I ESA, the property was owned by Hegeler Brothers, Inc. and consisted of a vacant lot that most recently operated as an equipment and materials storage area for a tree service company. While there were no standing buildings on site at the time of the Phase I ESA, the fire-damaged debris of a three (3) car garage remained on the property. According to Danville Fire Department records, the fire, caused by trespassers, occurred on December 24, 2008.

On September 12, 2013, the City of Danville, working with a qualified environmental consultant, completed a Phase I ESA on this property that identified the following Recognized Environmental Condition (REC): an historic planing mill and lumber yard that operated on the property from approximately 1907 to 1952. The Phase I ESA also identified the following RECs associated with adjacent properties: 1) a historical and active automotive repair and machine shop located at 511 Oak Street immediately west of the property; and 2) the presence of three (3) exempt petroleum underground storage tank (UST) systems on a northern up-gradient site, in close proximity to the property at 611 Oak Street.

In addition, the Phase I ESA identified one significant data gap, which has the potential to lead to the identification of additional RECs: the first developed (pre-1940) use of the property was not identified using standard and reasonably ascertainable historical data sources.

The Phase I ESA included a recommendation for confirmation sampling of soils and/or groundwater to confirm or refute the presence of hazardous substances and/or petroleum products associated with the identified RECs and significant data gap.

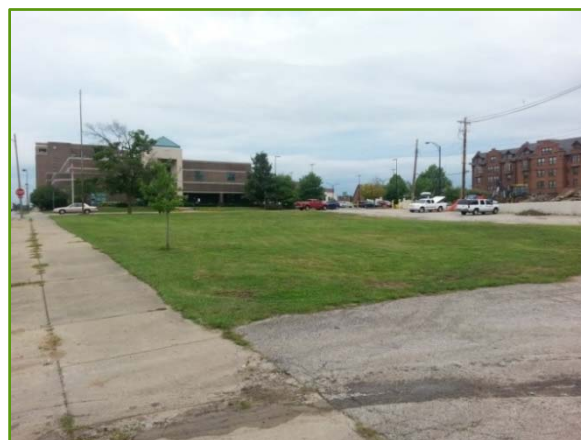
Figure 6.
400-406 North Hazel Street - Former City Hall Property

Currently, this 0.68-acre property is vacant land. Prior to building demolition, the property was used for City Hall.

The City of Danville, working with a qualified environmental consultant, completed a Phase I ESA on this property on January 23, 2015, in order to facilitate the sale and redevelopment of the site. This assessment identified the following recognized environmental conditions (RECs) on the property: 1) historical underground storage tanks (USTs) removed from the property; and 2) fill material of unknown origin used in grading activities on the property. The assessment also identified the following REC associated with an adjacent property: a historical gasoline station, and associated contamination, on the west adjoining site.

The Phase I ESA included a recommended for confirmation sampling of soils, soil gas and/or groundwater to confirm or refute the presence of hazardous substances and/or petroleum products associated with the identified RECs.

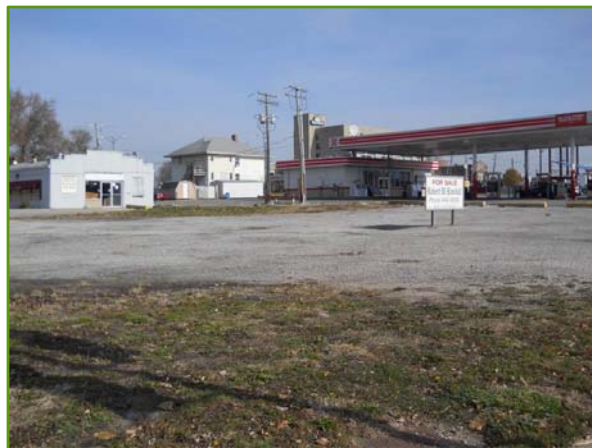
Figure 7.
1 North Logan Street - Former Filling Station

This 0.43-acre property was used as a historical gasoline filling station and automotive repair operations from approximately 1940 to 1990. At the time of the Phase I Environmental Site Assessment (ESA), the property was a vacant lot.

That assessment noted that the IEPA had issued a No Further Remediation (NFR) letter on the property in 2009; however, soil assessment activities leading to that NFR appear to have been limited to petroleum-indicator contaminants, and a groundwater assessment was not completed at that time. Therefore, the historic gasoline station was noted as a recognized environmental condition (REC) in the Phase I ESA. In addition, the assessment indicates the following RECs associated with adjacent

properties: 1) a historical and current filling station operation on the eastern adjacent property at 401 West Main Street, which received an NFR in 2004 for a Leaking Underground Storage Tank (LUST) incident but has five (5) underground storage tanks (USTs) still active; 2) a historical filling station operation on the potentially up-gradient site at 1 North Gilbert Street, with at least two (2) LUST incidents remaining unresolved; and 3) a historic automotive repair operation and fuel storage on the northern adjacent property at 407 and 407 ½ West Main Street from approximately 1951 to 1990. In addition, the Phase I ESA identified the following significant data gap, which has the potential to lead to the identification of additional RECs: a response to a November 2012 FOIA request to the IEPA had not been received as of the date of the final Phase I ESA report.

The Phase I ESA included a recommendation for confirmation sampling of soils and groundwater to confirm or refute the presence of petroleum products and/or hazardous substances associated with the identified RECs and the significant data gap.

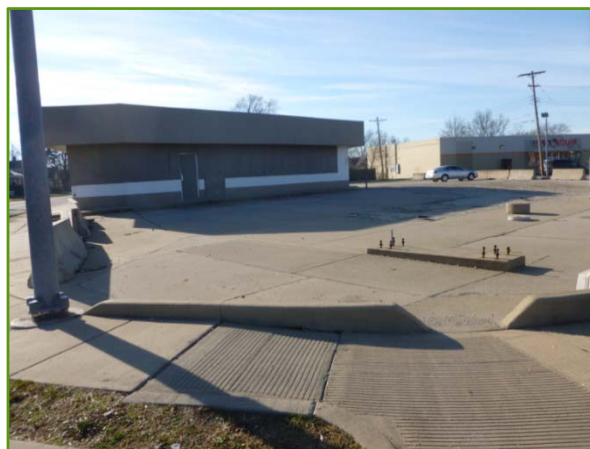
Figure 8.
1232 East Main Street - Former Filling Station

This 0.49-acre property operated as an historic automotive filling station from approximately 1932 to 2006, most recently occupied by Super Pantry #29. At the date of the Phase I Environmental Site Assessment, the property was a vacant automotive filling station.

This assessment identified the following Recognized Environmental Condition (REC): a historical gasoline filling station and limited automotive repair operation at the property from approximately 1932 to 2006, with previous assessment work indicating that the property's soil and groundwater are contaminated with petroleum compounds, extending to northern, western and eastern adjacent properties. In addition, the assessment identified the following REC associated with an adjacent property: the historical filling station operation on the northern adjacent property at 1233 East Main Street from approximately 1930 to 1991. The Phase I ESA identified the following significant data gap that has the potential to lead to the identification of additional RECs: a Fonner's 1-Hour Dry Cleaner, listed in the 1961 city directory on the east adjacent property at 1300 East Main Street, which may have had dry cleaning operations on site or may have served only as a storefront drop-off location.

The Phase I ESA included a recommendation for confirmation sampling of soils and groundwater to confirm or refute the presence of petroleum products and/or hazardous substances associated with the identified RECs and significant data gaps.

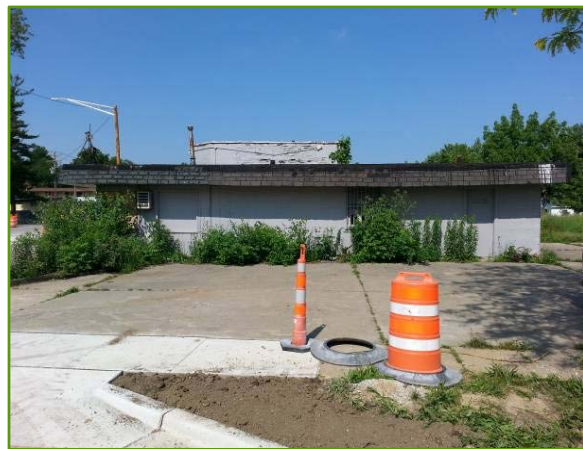
Figure 9.
1833 East Main Street - Former Service Station

At the time of the Phase I ESA, this 0.34-acre property was a vacant former automotive service station. Its former uses included a historical gasoline station and automotive repair operations, auto sales, car wash, and auto detail shop.

The City of Danville, working with a qualified environmental consultant, completed a Phase I ESA on this property on September 12, 2013, which identified the following recognized environmental conditions (RECs) associated with the property: 1) a historical gasoline station operation on the property from approximately 1938 to 1966, with at least three (3) underground storage tanks (USTs) identified on the property; and 2) the historical use of the property for automotive repair operations from approximately 1938 to the mid-1960s, and possibly more recently with used auto sales and car wash operations, with at least one (1) subgrade hydraulic hoist and three (3) 55-gallon drums with unidentified contents located in a shed on the property, with oily staining on the ground around the drums. In addition, the assessment identified the following REC associated with an adjacent property: the historical automotive filling and repair operations on the up-gradient, east adjacent property at 1901-1905 East Main Street.

The Phase I ESA identified the following significant data gaps, which have the potential to lead to the identification of additional RECs: 1) a lack of historical knowledge of the property by the current owner, Mr. Bhupendrabhai S. Patel; 2) no available documentation of the onsite UST removals or analytical results for any subsequent confirmation samples; 3) the lack of visibility of the floors in the main building structure and in the concrete block shed due to the large amount of debris, including the fire-damaged and falling roof in the main building.

The Phase I ESA included a recommended for confirmation sampling of soils and/or groundwater to confirm or refute the presence of hazardous substances and/or petroleum products associated with the identified RECs and significant data gaps.

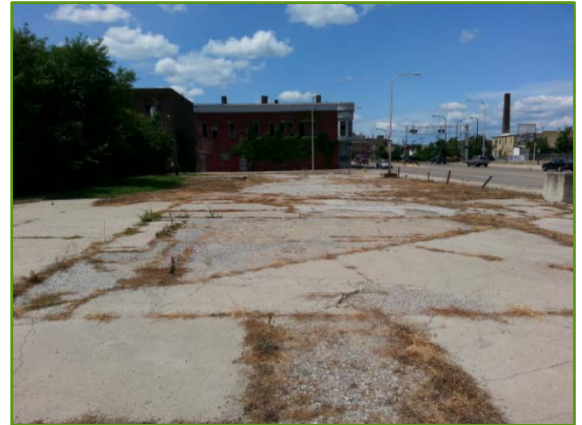
Figure 10.
402-418 E. Main Street - Former Nixon Standard

The City of Danville, working with a qualified environmental consultant, completed a Phase I ESA on this property on September 6, 2013. The Phase I ESA identified the following recognized environmental conditions (RECs) associated with the property: 1) historic filling station operations conducted at 402 East Main Street with the use of at least three (3) underground storage tanks (USTs) which may remain at the property; 2) historical filling station operations conducted at 410 East Main Street, with pre-1974 USTs possibly remaining at the site²; and 3) the historical presence of chlorinated solvent contamination at 410 East Main Street, as documented from groundwater sampling in 1989 and 1990. In addition, the Phase I ESA identified the following RECs associated with adjacent properties: 1) migration of possible contamination related to the filling station operation historically conducted at 439 East Main Street, northeast and up-gradient to the property; and 2) the possible presence of contamination from a UST that is historically depicted on the land parcel that separates the east and west lots of the property.

In addition, the Phase I ESA identified the following significant data gaps that have the potential to lead to the identification of additional RECs: 1) the lack of information confirming or denying possible historic dry cleaning operations at 412 East Main Street; 2) the lack of information confirming or denying the presence of pre-1974 USTs and possible releases associated with the USTs at 402 East Main Street; 3) the lack of information confirming or denying the presence of pre-1974 USTs and possible releases associated with the pre-1974 USTs at 410 East Main Street; and 4) the lack of response from the current property owner, Mr. Jason Johnson, concerning the Owner/Occupant Questionnaire and/or discussion concerning the property.

The Phase I ESA included a recommendation for confirmation sampling of soils and/or groundwater to confirm or refute the presence of hazardous substances and/or petroleum products associated with the identified RECs and significant data gaps.

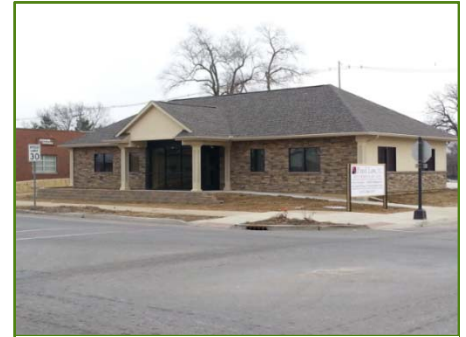
Figure 11. 401 North Vermilion Street - Redeveloped as Law Office

This 0.34-acre property operated as a gasoline station from approximately 1940 to the mid-1980s, then as an automobile repair operation from approximately 1980 to 2012.

On September 3, 2013, the City of Danville, working with a qualified environmental consultant, completed a Phase I ESA update for this property. The original Phase I ESA was completed on December 10, 2012. Recognized environmental conditions (RECs) identified in the original Phase I ESA included: 1) a historical gasoline station operation at the property from approximately 1940 to the mid-1980s (with at least six (6) underground storage tanks (USTs) possibly having been utilized at the property); and 2) historical use of the property for automotive repair operations from approximately 1980 to 2012. The Phase I ESA also indicated historic automotive and UST operations on the up-gradient properties within the 400 block of North Vermilion Street. The Phase I ESA Update identified the following significant data gaps that have the potential to lead to the identification of additional RECs: 1) the previous Phase I ESA was not available for review during the Phase I ESA Update; and 2) no documentation for on-site UST removals or analytical results for any subsequent confirmation soil samples was available.

The Phase I ESA Update included an opinion recommending additional sampling of soil and groundwater to define the extent of hazardous substances and/or petroleum products associated with the identified RECs and the significant data gaps.

The Phase II ESA included a recommendation to enroll the site in the Illinois EPA's Site Remediation Program. In addition, the ESA noted that for any future development or earthwork on the property, any disturbed material will need to be managed if offsite disposal is proposed. It also noted the possibility of an orphan UST on the property, which, if disturbed in the future, would become regulated and its removal required. In that event, a permit from the Office of the State Fire Marshal (OFSM) and subsequent confirmation soil sampling would be needed at the time of the UST removal.

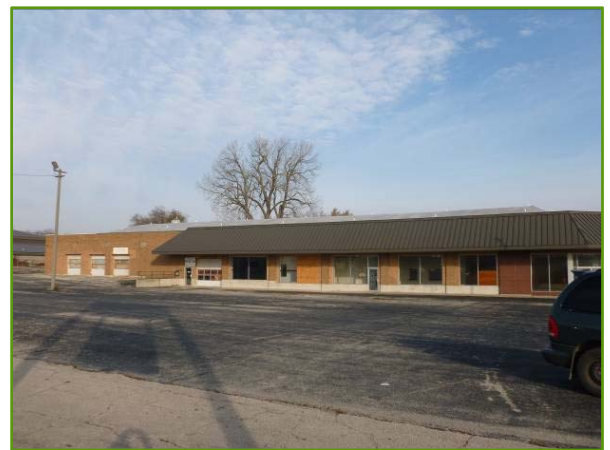
Figure 12.
422 North Vermilion Street - Former Auto Dealership

At the time of the June 2014 Phase I Environmental Site Assessment (ESA), this 2.03-acre property was a vacant automotive dealership and former automotive repair operation most recently occupied by the Win C. Smith dealership. At the time of the ESA, the property was used for miscellaneous storage, which constituted no change from the previous Phase I ESA dated February 27, 2013. The property was occupied by a grocery store from approximately 1947 to 1984, then a car dealership with on-site automotive repair services from approximately 1985 to 2003.

Working with a qualified environmental consultant (QEC), the City of Danville Completed a Phase I ESA on this property on February 27, 2013. This ESA identified the following recognized environmental conditions: 1) the historical use of the property for automotive repair and painting operations from approximately 1985 to 2003; and 2) the historical use of a used oil underground storage tank (UST) at the property during the 1990s³.

Working with a QEC, the City of Danville completed a Phase II Environmental Site Assessment on this property on September 24, 2013. The purpose of this assessment was to conduct soil and groundwater investigative sampling at or near the RECs identified in the February 27, 2013, Phase I ESA. This Phase II ESA involved the completion of soil borings and the installation of temporary groundwater monitoring wells to facilitate the collection of soil and groundwater samples.

This Phase I ESA identified the following RECs: 1) semi-volatile organic compound (SVOC) subsurface soil contamination documented at the property during 2013 Phase II ESA activities, which may be a result of historical automotive repair operations that occurred from approximately 1985 to 2003; 2) lead groundwater contamination documented at the property during 2013 Phase II ESA activities, which may be a result of historical automotive repair operations that occurred from approximately 1985 to 2003; and 3) subsurface soil SVOC contamination and lead groundwater contamination at the former location of a used oil UST.

The assessment identified the following significant data gaps that have the potential to lead to the identification of additional RECs: 1) Limitations encountered during the site reconnaissance created a data gap that impaired the inspection of the property's facility; AND 2) One (1) fuel AST was observed in the southwest section of the property's building, and the overall integrity of the tank and the surrounding floor surface could not easily be evaluated, resulting in the data gap.

The Phase I ESA included a recommendation for confirmation sampling of soils and/or groundwater to confirm or refute the presence of petroleum products and/or hazardous substances associated with the RECs and significant data gaps.

The Phase II ESA included a recommendation that the property be enrolled in the Illinois EPA's Site Remediation Program (SRP) for the purpose of conducting additional soil and groundwater investigations to delineate plumes and quantify all risk conditions. The ESA noted that if future development or earthwork occurs on the property, any disturbed material will need to be managed if offsite disposal is proposed. The ESA also noted the possibility of the existence of an orphan UST on the site, which may have existed prior to 1974, which would make it unregulated by the Office of the State Fire Marshall (OSFM). If future development disturbs any UST, it would become regulated and its removal would be required. An OSFM permit and subsequent confirmation soil sampling would be needed at the time of the UST removal.

The Phase I ESA included a recommendation for additional sampling of soils, soil gas, and/or groundwater to delineate, confirm, or refute the presence of the established petroleum products and/or hazardous substances contamination associated with the indicated RECs and significant data gaps.

Subsequent to the Phase I ESA update, the City of Danville, working with a QEC, decommissioned and removed the AST and disposed of an above-ground recycled fuel burner in order to facilitate the collection of a soil sample beneath the burner. These activities were completed in October and November 2014.

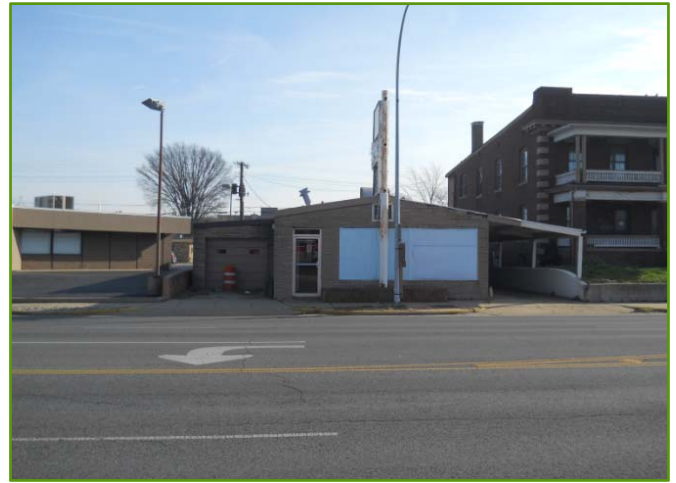
Figure 13.
817 North Vermilion Street - Former Dry Cleaner

The City of Danville, working with a qualified environmental consultant, completed a Phase I ESA on February 14, 2013, which identified the following REC on the property: historical dry cleaning operations at the property from approximately 1960 to 2001. It also identified the following RECs associated with adjacent properties: 1) historical filling station operations on the north adjacent property at 821 North Vermilion Street on which approximately six (6) underground storage tanks (USTs) were operated; 2) historical and current filling station and/or UST operations on up-gradient properties at 824, 900, and 901 North Vermilion Street, including separate LUST incidents recorded at 824 and 901 North Vermilion Street.

The assessment identified the following significant data gaps that have the potential to lead to the identification of additional RECs: 1) the number of items stored within the property's building significantly limited a thorough inspection of the structure's interior; 2) an unidentified pipe was located near the gas meter on the building's east side, which could possibly be related to on-site utilities; and 3) interviews with past owners knowledgeable of the dry cleaning business operations could not be conducted because the past property owners are deceased.

The Phase I ESA included recommendations for confirmation sampling of soils and/or groundwater to confirm or refute the presence of hazardous substances and/or petroleum products associated with the RECs and significant data gaps, as well as further investigation of the origins of the piping on the east side of the building's exterior.

The Phase II ESA recommendations included additional soil and groundwater investigation at the property. During the completion of the Phase II ESA, the QEC was not able to perform a thorough investigation due to the presence of the building and its contents, which dominate the property. The Phase II ESA recommends removal of the structure and/or its contents in order to provide access to likely target areas of the investigation. The ESA notes that if future development or earthwork occurs on the property, any disturbed material will need to be managed if offsite disposal is proposed. Also, the possibility of an orphan UST may exist, and if it does, it may have existed prior to 1974. In that case, it would be considered unregulated by the Office of the State Fire Marshal (OSFM). If any future redevelopment disturbs any UST, it would become regulated and its removal would be required. An OSFM permit and subsequent soil sampling would be needed at the time of the UST removal.

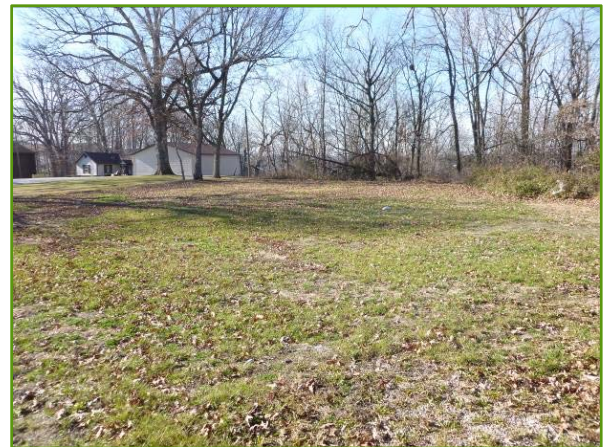
Figure 14.
2508 North Vermilion Street - Former Residential Building

The City of Danville, working with a qualified environmental professional, completed a Phase I ESA on this property on February 19, 2013. The ESA identified the following RECs associated with adjacent properties: 1) the filling station operation on the northern adjacent property, 2602 North Vermilion Street, from approximately 1966 to present, with three (3) underground storage tanks (USTs) currently in use; 2) a filling station operation on the up-gradient, northern surrounding property at 2606 North Vermilion Street, from approximately 1971 to present, with four (4) USTs currently in use and two (2) open leaking underground storage tank (LUST) incidences recorded against the site; and 3) a historical filling station operation on the northeastern adjacent property, 2601 North Vermilion Street, from approximately 1966 to 1975, and the associated significant data gap.

The Phase I ESA identified the following significant data gaps that have the potential to lead to the identification of additional RECs: 1) an owner interview could not be completed for 2508 North Vermilion Street; 2) the northeast adjacent site at 2601 North Vermilion Street was historically a filling station from approximately 1966 to 1976, and no information related to USTs was available for this site from the OSFM.

The Phase I ESA included the recommendation for confirmation sampling of soils and/or groundwater to confirm or refute the presence of petroleum products associated with the RECS and significant data gaps.

The QEC's recommendations in the Phase II ESA included additional subsurface investigations in order to assess the presence or extent of contamination across the property. As forested, uneven or steep terrain created challenging or altogether preclusive conditions, groundwater depth further limited the thoroughness of the Phase II ESA. To confirm or deny the presence of groundwater contamination on the property, the installation of monitoring well(s) was recommended. Furthermore, land clearing and/or use of an ATV drill rig may be required in order to access the western half of the property.
